OMNISERIES

TESTED. TRUSTED. TOUGHER THAN EVER...

WHAT SETS US APART?

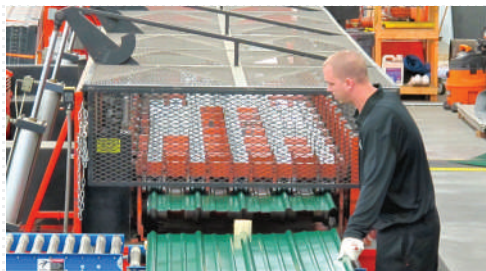
ADVANCED TOOLING

Advanced State-of-the-Art Tooling is another area of excellence in Everlast Roofing's roll formed products. Using additional stands places less stress on the formed radius of our panel providing for the most consistent panel profile on the market.

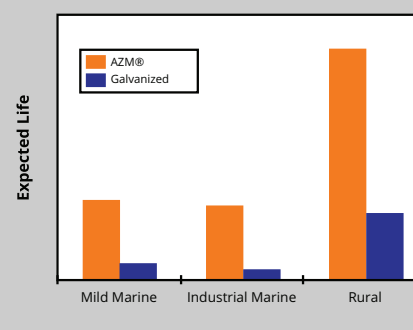
AZM® Steel vs Galvanized Steel

AZM®: MORE SUPERIOR CORROSION RESISTANCE

G100

AZ50®

AZM® 125

The **OMNI series includes the latest in corrosion resistance with the Next Generation AZM® coating with Activate Technology, which provides for the best corrosion resistance in the industry.** This first-of-its-kind metallic coating introduces magnesium into the aluminum-zinc alloy coating, which improves galvanic protection by activating the aluminum.

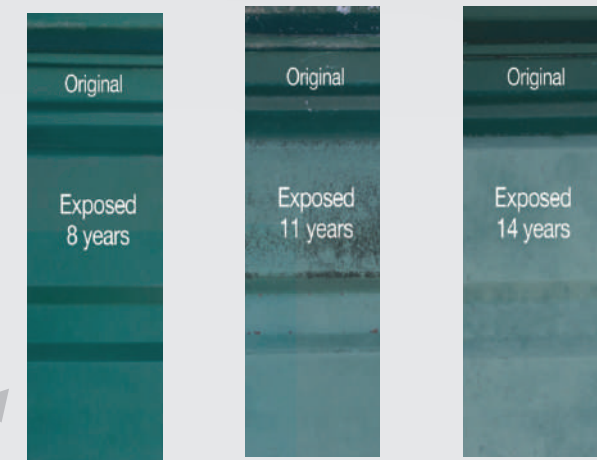
Colorbond® COMPETITOR

NEXT GENERATION | **NEW SMP TECHNOLOGY** | **PREVIOUS SMP TECHNOLOGY**

Panels shown above are actual samples that were exposed to real-life outdoor conditions on the same building. **COLORBOND®** is trending to surpass the competitor current and previous SMP Technology.

COLORBOND® has been tested in some of the harshest regions of the world, where corrosive environments and high solar intensity take their toll on painted products. Even with over 50 years of proven excellent durability in locations across the globe, Blue Scope Steel and Everlast Roofing continue to test and evaluate **COLORBOND®** for resistance to corrosion, dirt retention, chalking, color fade and gloss retention.
